REQUEST FOR PROPOSALS (RFP)

2024
Probable Maximum Flood Study

CPUD retained Mead & Hunt, Inc. (Mead & Hunt) to perform a focused spillway assessment comprised of four components: data collection and desktop study; detailed field inspection; focused potential failure modes analysis (PFMA); and reporting.

Warren Hayden, PE and Drake Hughes, PE of Mead & Hunt performed a detailed inspection of the Middle Fork Dam spillway on September 10, 2018. The weather conditions at the time of inspection were sunny and warm and there was approximately 0.5 inch of water flowing over the spillway crest. The inspection proceeded from the crest of the spillway to the toe of the chute.

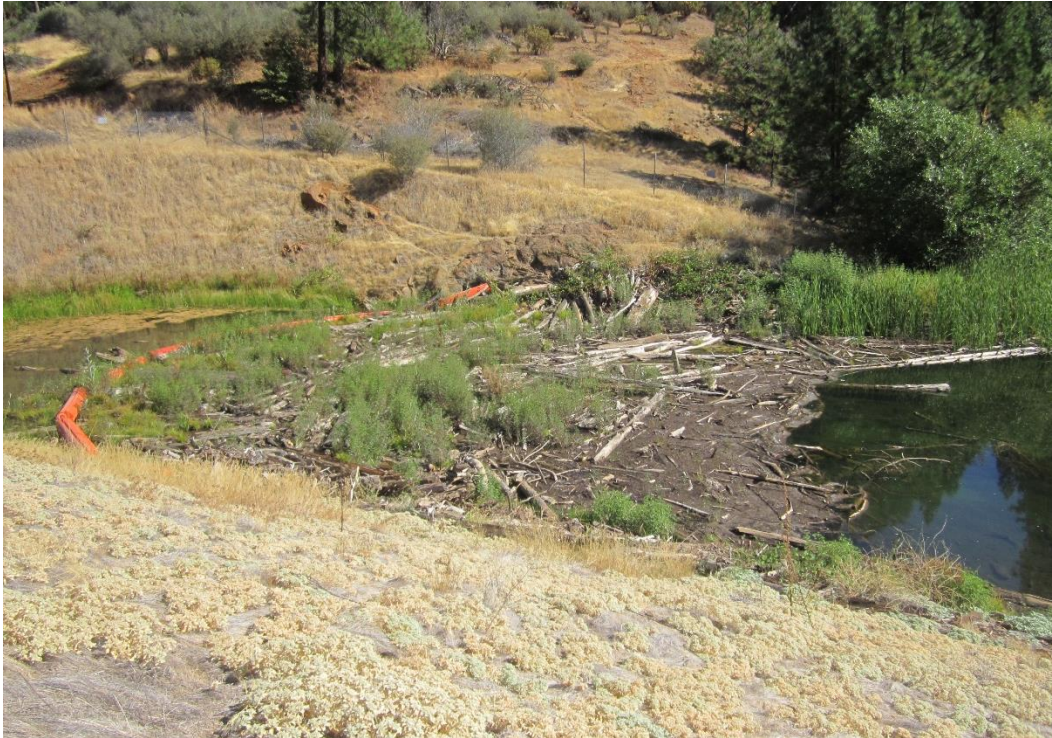
The spillway approach channel contained a substantial amount of woody debris upstream of the log boom (**Figure 3-1**). CPUD staff indicated that they planned to remove the debris when the reservoir level had dropped, and the approach channel was dewatered sufficiently to support heavy equipment.

Figure 3-1: Woody debris upstream of log boom across spillway approach channel.

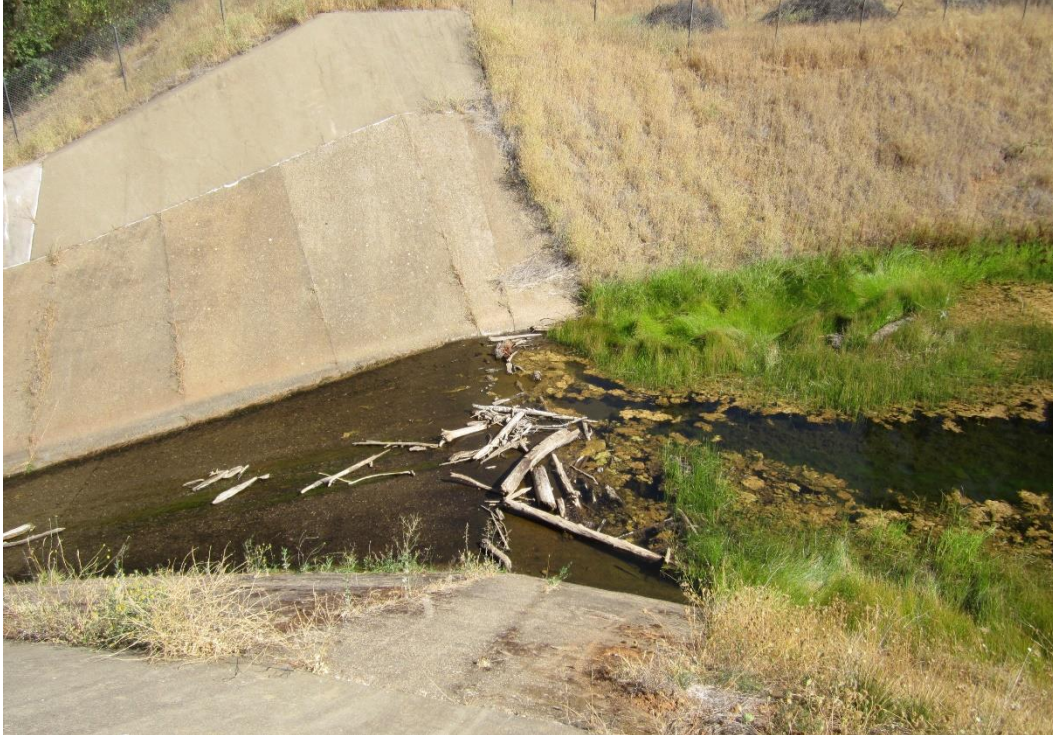
The spillway crest was level, in good condition, with a moderate amount of small woody debris at rest there (**Figure 3-2**).

Figure 3-2: Spillway crest with moderate amount of woody debris.

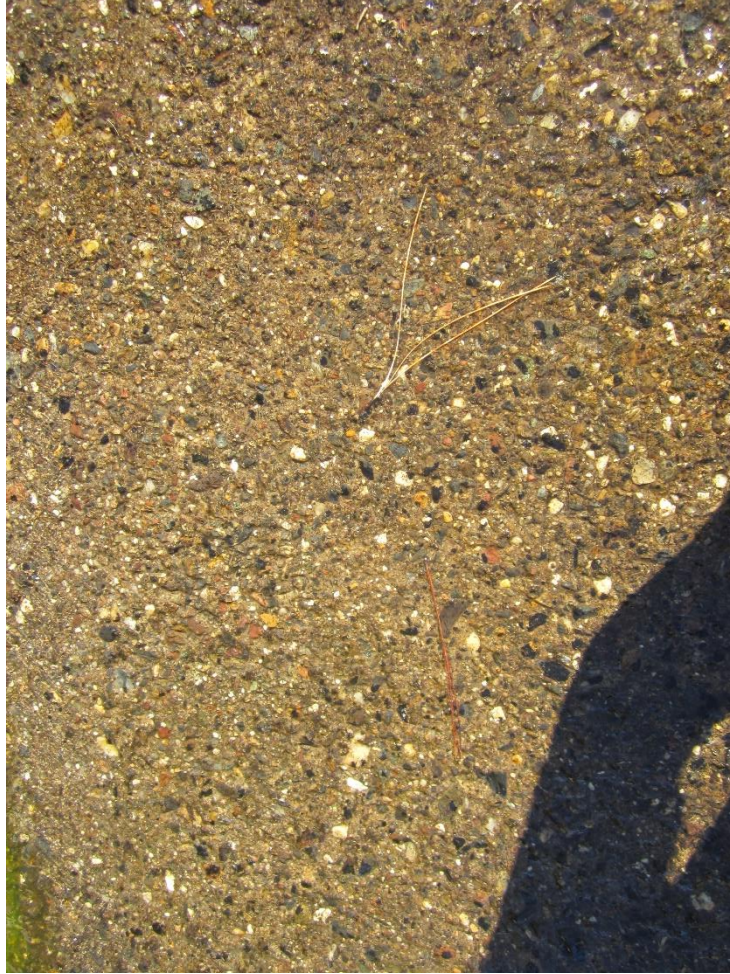
Figure 3-4: Exposed aggregate in bottom slab.

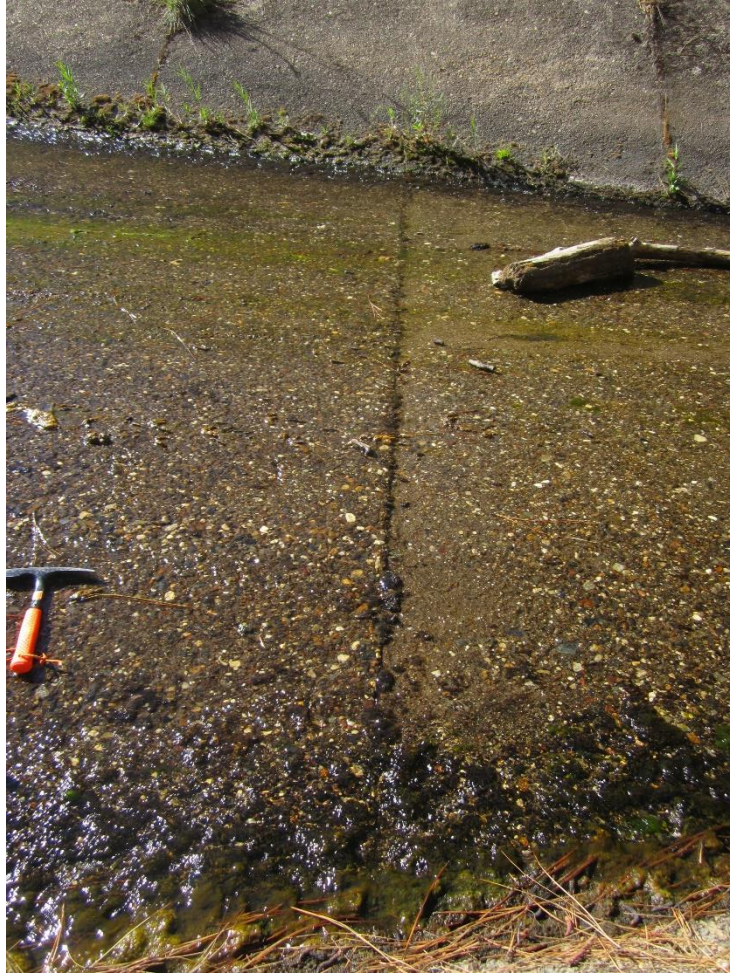
The transverse joint at Station 2+25 was tight with an approximate positive offset (downstream slab lower than upstream slab) of 1/8" (**Figure 3-5**). Downstream of this joint, each blanket drain outlet pipe daylighting near the right and left edges of the bottom slab was in good condition.

Figure 3-5: Transverse joint at Station 2+25.

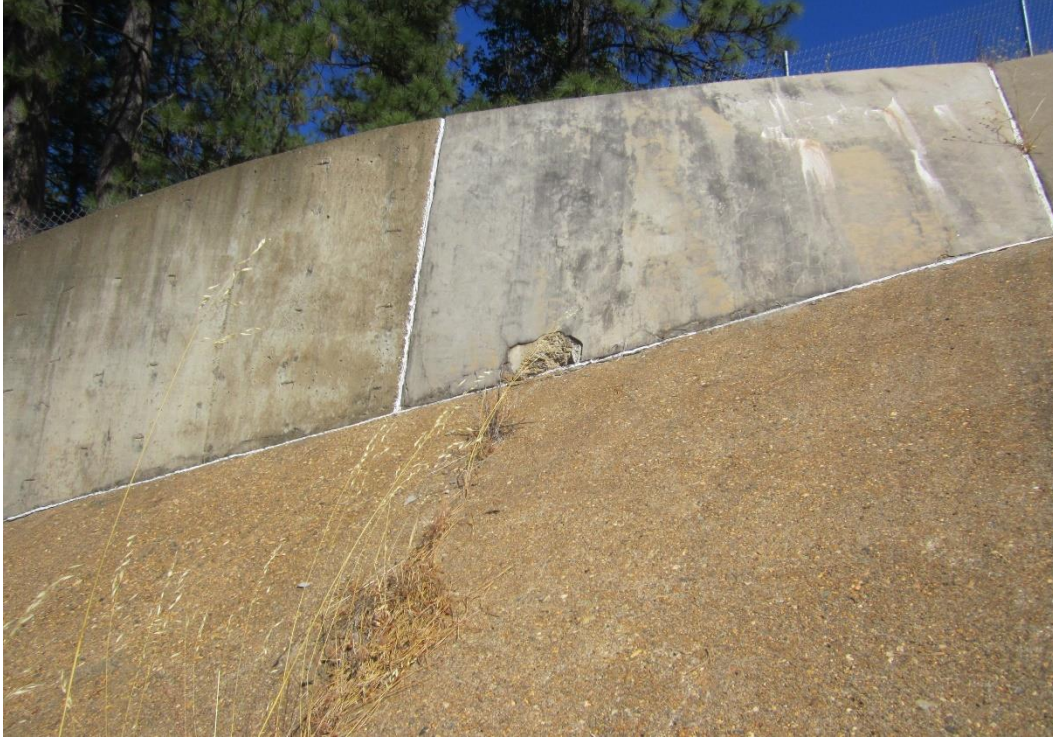
There was an area of spalled concrete at the base of the right side slope extension at approximately Station 2+42 (**Figure 3-6**). While this is essentially cosmetic damage, it should be chipped out to sound concrete and patched with repair mortar.

Figure 3-6: Spalled concrete at base of right side slope extension at Station 2+42.

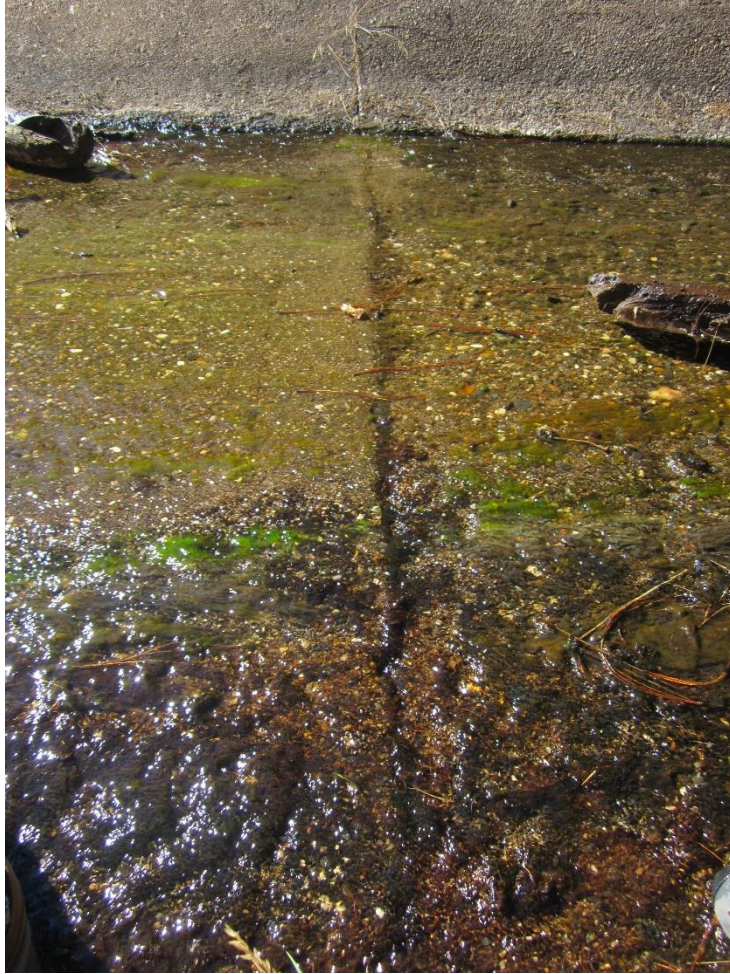
Figure 3-7: Transverse joint at Station 2+50.

The transverse joint at Station 2+50 was not measured for opening and offset, but did not appear to have an appreciable amount of either (**Figure 3-7**). An approximate 12" length at the left edge of the joint had been previously patched. Downstream of this joint, each blanket drain outlet pipe daylighting near the right and left edges of the bottom slab was in good condition. There were three transverse cracks observed between transverse joints at Stations 2+50 and 2+75. The first crack (2A) was located at approximately 10-10.5' (all crack locations were measured along the channel slope from the upstream joint) and had been previously patched (**Figure 3-8**). The second crack (2B) was located at approximately 14' and had a maximum opening of approximately 3/8" (**Figure 3-9**). The third crack (2C) was located at approximately 18.5' and had no appreciable opening nor offset (**Figure 3-10**).

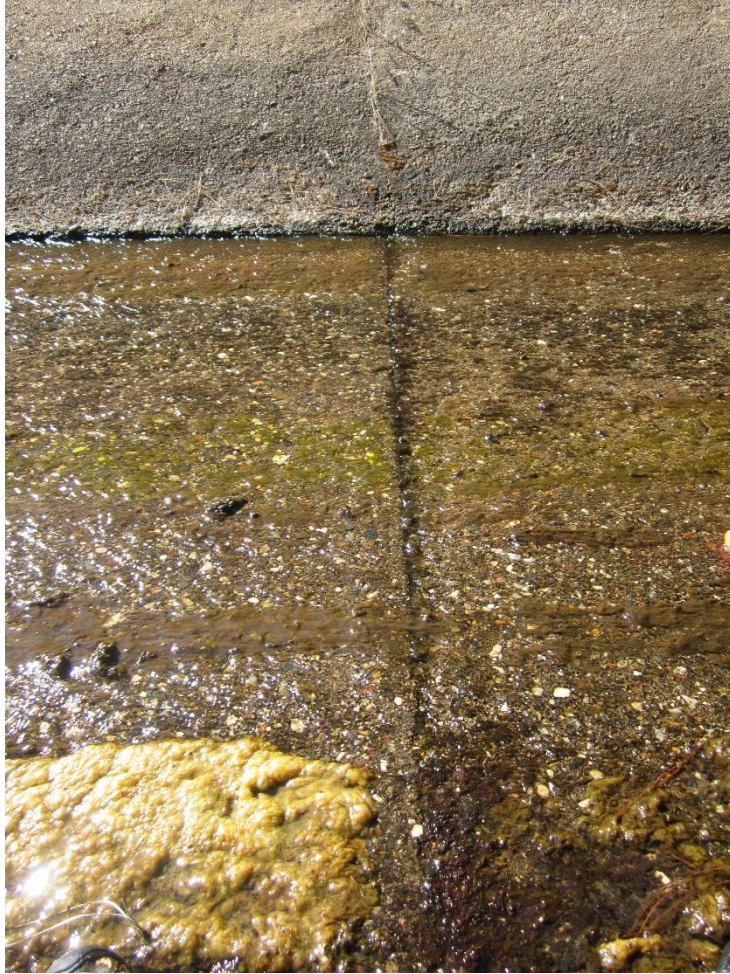
Figure 3-11: Transverse joint at Station 2+75.

The transverse joint at Station 2+75 had an approximate positive offset of 1/4" (**Figure 3-11**). Downstream of this joint, each blanket drain outlet pipe daylighting near the right and left edges of the bottom slab was in good condition. There was a little gravel observed downstream of the right blanket drain outlet pipe (**Figure 3-12**). Presumably this gravel originated from the gravel blanket upstream of the cutoff wall at Station 2+75. There was one transverse crack observed between transverse joints at Stations 2+75 and 3+00. That crack (3A) was located at approximately 11.5' and was tight (**Figure 3-13**).

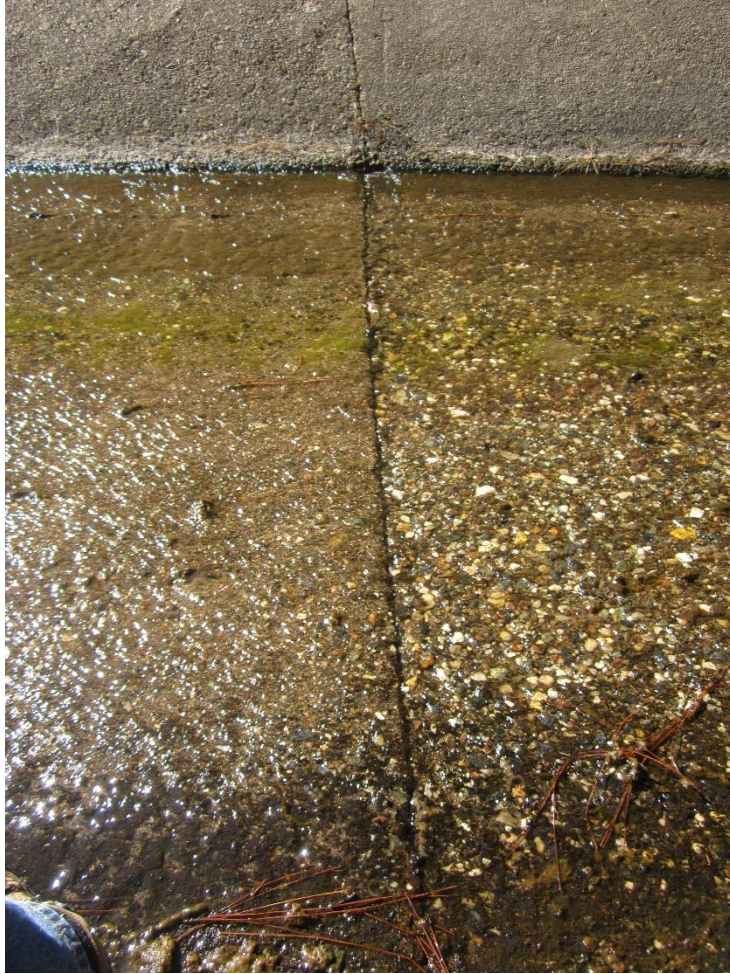
Figure 3-14: Transverse joint at Station 3+00.

The transverse joint at Station 3+00 had an approximate positive offset of 1/4" (**Figure 3-14**). Downstream of this joint, each blanket drain outlet pipe daylighting near the right and left edges of the bottom slab was in good condition. The joint between the right side slope slabs at approximately Station 3+00 had a maximum opening of approximately 1/4" and a positive offset of 2" at the top of the slope (**Figure 3-15**). We suspect this offset is being caused by root intrusion from nearby trees. The seventh CSIR recommended filling this joint with sealant; however, that had not been done at the time of this inspection. There were two transverse cracks observed between transverse joints at Stations 3+00 and 3+25. The first crack (4A) was located at approximately 15.5' and spanned about half the bottom slab (**Figure 3-16**). The second crack (4B) was located at approximately 22.5' and had a maximum opening of approximately 1/4" (**Figure 3-17**). Portions of this crack had been previously patched.

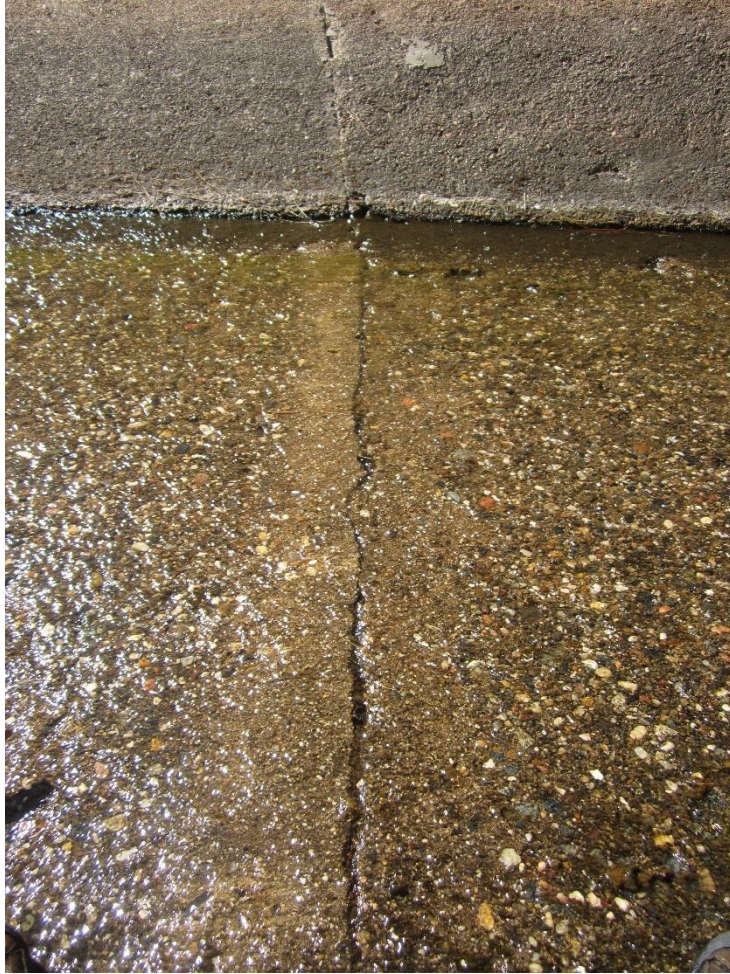
Figure 3-18: Transverse joint at Station 3+25.

The transverse joint at Station 3+25 had a maximum opening of approximately 1/4"-1/2" (**Figure 3-18**). On the right side of the joint there was a hole approximately 6" long and 4" deep (**Figure 3-19**). This hole should be patched with repair mortar. Downstream of this joint, each blanket drain outlet pipe daylighting near the right and left edges of the bottom slab was in good condition. There was one transverse crack observed between transverse joints at Stations 3+25 and 3+50. That crack (5A) was located at approximately 9.75' (**Figure 3-20**).

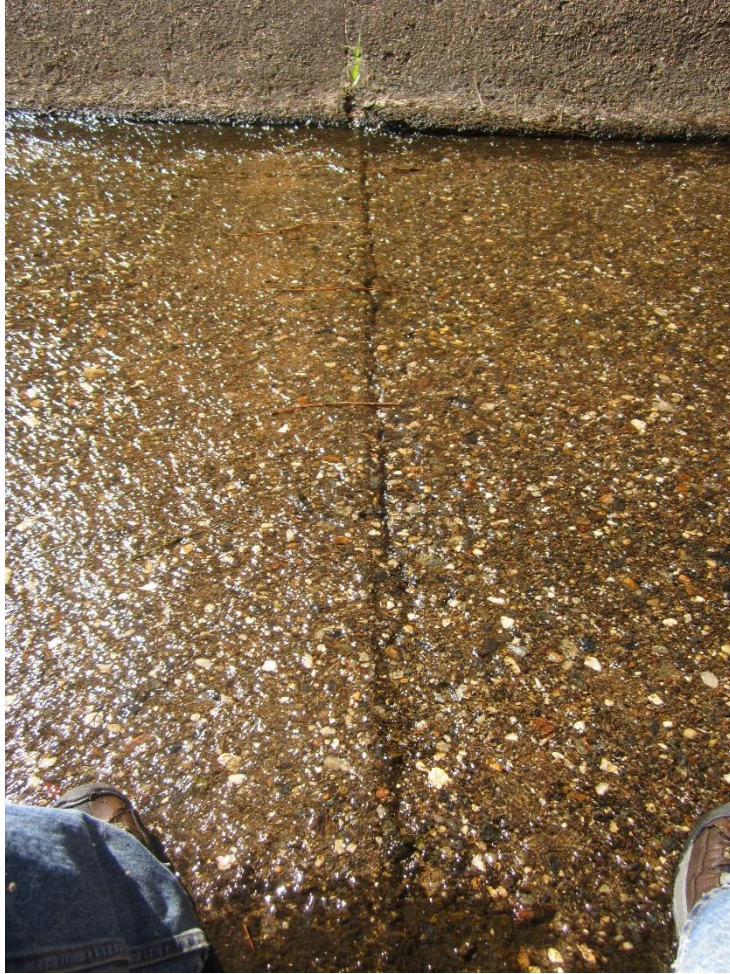
Figure 3-21: Transverse joint at Station 3+50.

The transverse joint at Station 3+50 had an approximate positive offset of 1/2" (**Figure 3-21**). Downstream of this joint, each blanket drain outlet pipe daylighting near the right and left edges of the bottom slab was in good condition. There were two transverse cracks observed between transverse joints at Stations 3+50 and 3+75. The first crack (6A) was located at approximately 8' near where the blanket drain outlet pipe daylight (**Figure 3-22**). The second crack (6B) was located at approximately 13' and had a maximum opening of approximately 1/8"-1/2" (**Figure 3-23**). Portions of this crack had been previously patched.

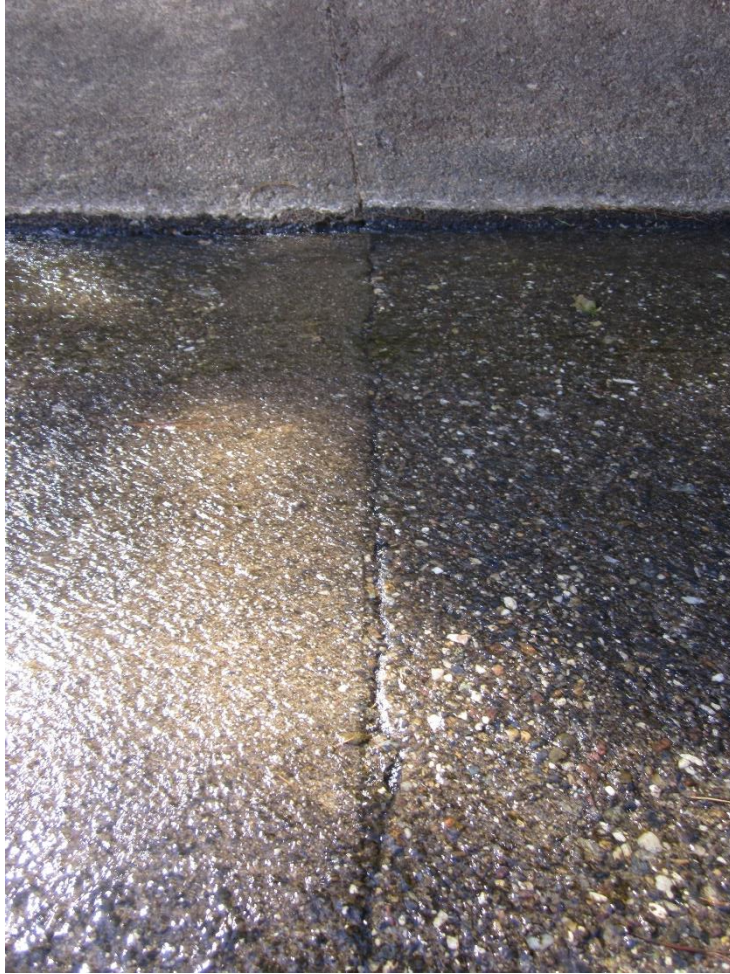
Figure 3-24: Transverse joint at Station 3+75.

The transverse joint at Station 3+75 had a maximum opening of approximately 5/8" (**Figure 3-24**). Downstream of this joint, each blanket drain outlet pipe daylighting near the right and left edges of the bottom slab was in good condition. There were three transverse cracks observed between transverse joints at Stations 3+75 and 4+00. The first crack (7A) was located at approximately 3.5' and had a maximum opening of approximately 1/8" (**Figure 3-25**). The second crack (7B) was located at approximately 12.5' and had a maximum opening of approximately 1/4" (**Figure 3-26**). The third crack (7C) was located at approximately 23' and had a maximum opening of approximately 1/2" (**Figure 3-27**).

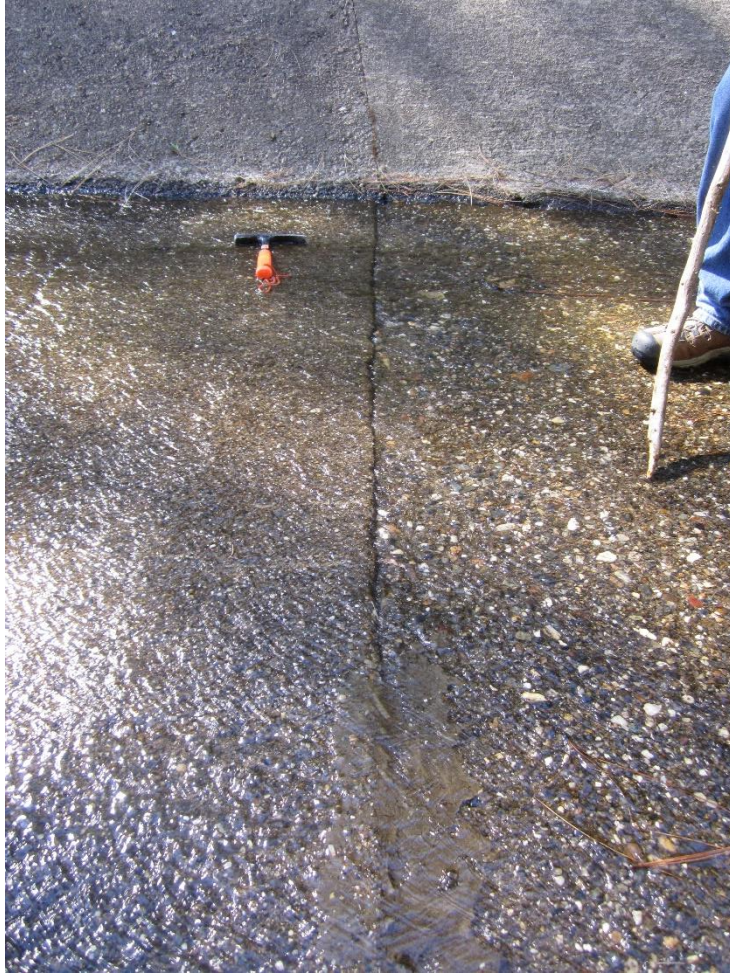
Figure 3-28: Transverse joint at Station 4+00.

The transverse joint at Station 4+00 had an approximate positive offset of $3/8''$ - $1/2''$ and had been previously repaired along its right side (**Figure 3-28**). Downstream of this joint, each blanket drain outlet pipe daylighting near the right and left edges of the bottom slab was in good condition. There was a small spalled area upstream of the right blanket drain outlet pipe (**Figure 3-29**). There were two transverse cracks observed between transverse joints at Stations 4+00 and 4+25. The first crack (8A) was located at approximately 12' and had a maximum opening of approximately $1/4''$ (**Figure 3-30**). There is a hole approximately 3.5" deep in the bottom of the left side slab at its junction with the bottom slab (**Figure 3-31**). This hole should be patched with repair mortar. The second crack (8B) was located at approximately 24.75' and was tight (**Figure 3-32**).

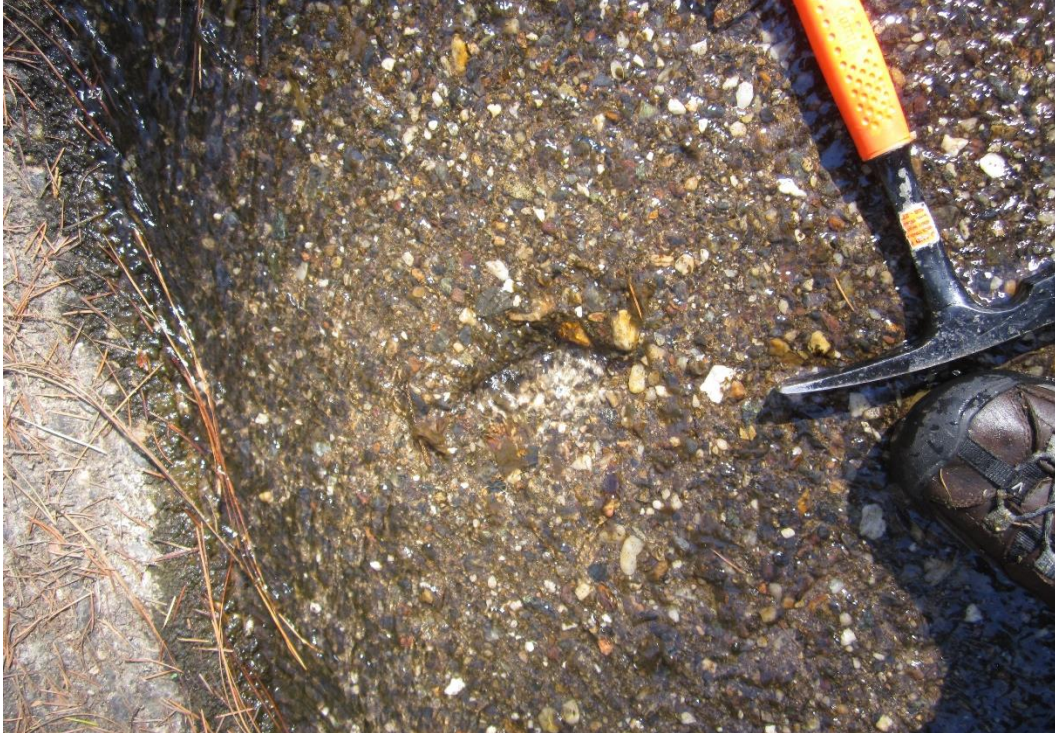
Figure 3-29: Spall upstream of right blanket drain outlet pipe.

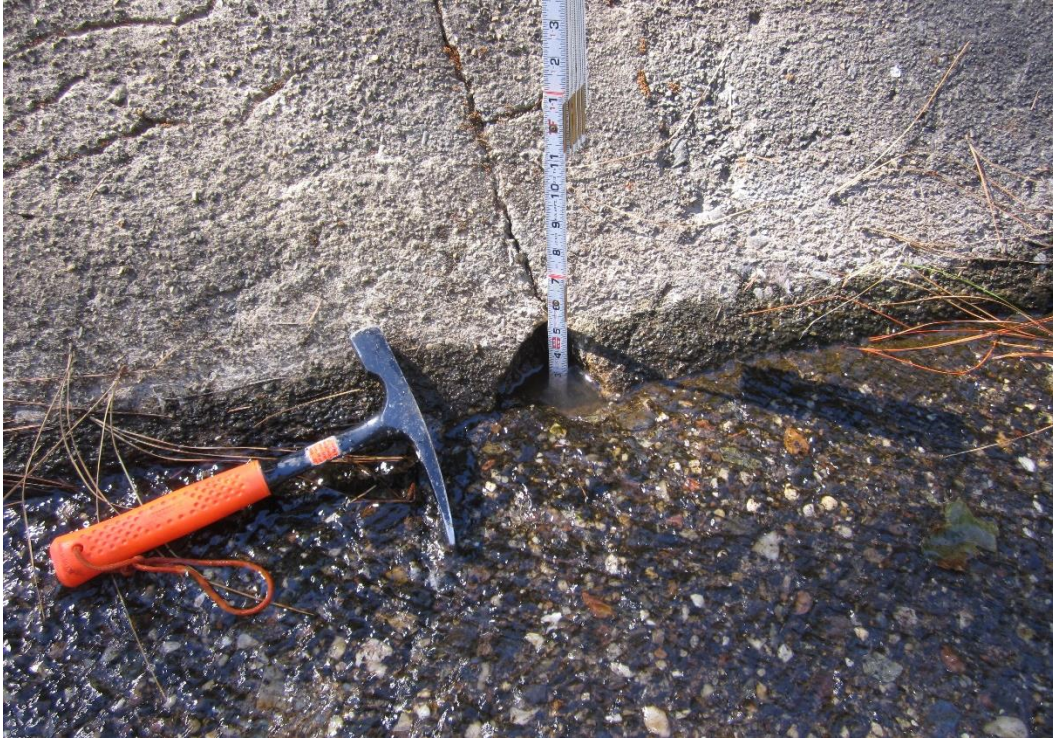
Figure 3-31: Hole in bottom of left side slab at Station 4+00.

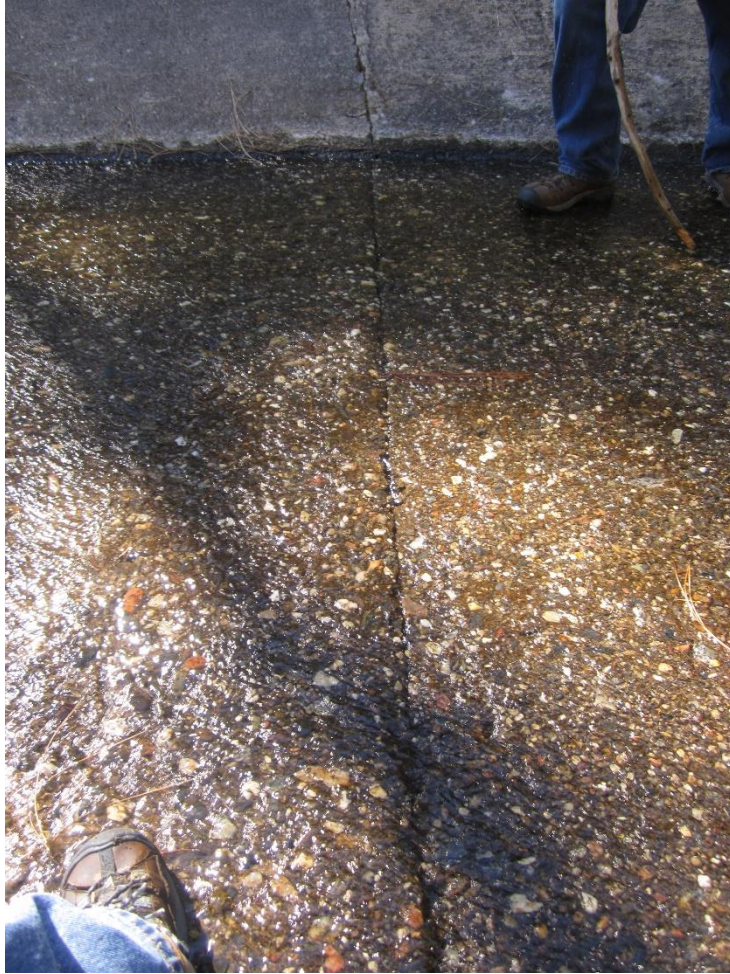
Figure 3-33: Transverse joint at Station 4+25.

The transverse joint at Station 4+25 had an approximate positive offset of 1/2" and maximum opening of approximately 1/4" (**Figure 3-33**). Downstream of this joint, each blanket drain outlet pipe daylighting near the right and left edges of the bottom slab was in good condition. There were four transverse cracks observed between transverse joints at Stations 4+25 and 4+50. The first crack (9A) was located at approximately 6.5' and was tight and had been previously patched (**Figure 3-34**). The second crack (9B) was located at approximately 8.5' and was tight (**Figure 3-35**). The third crack (9C) was located at approximately 12.5' and the right side had been previously patched but was raveling open approximately 1/8" (**Figure 3-36**). At the left side of this crack there are two holes approximately 2.5" deep in the bottom of the left side slab at its junction with the bottom slab (**Figure 3-37**). These holes should be patched with repair mortar. The fourth crack (9D) was located at approximately 25' and had a maximum opening of approximately 1/16" and had been previously patched (**Figure 3-38**).

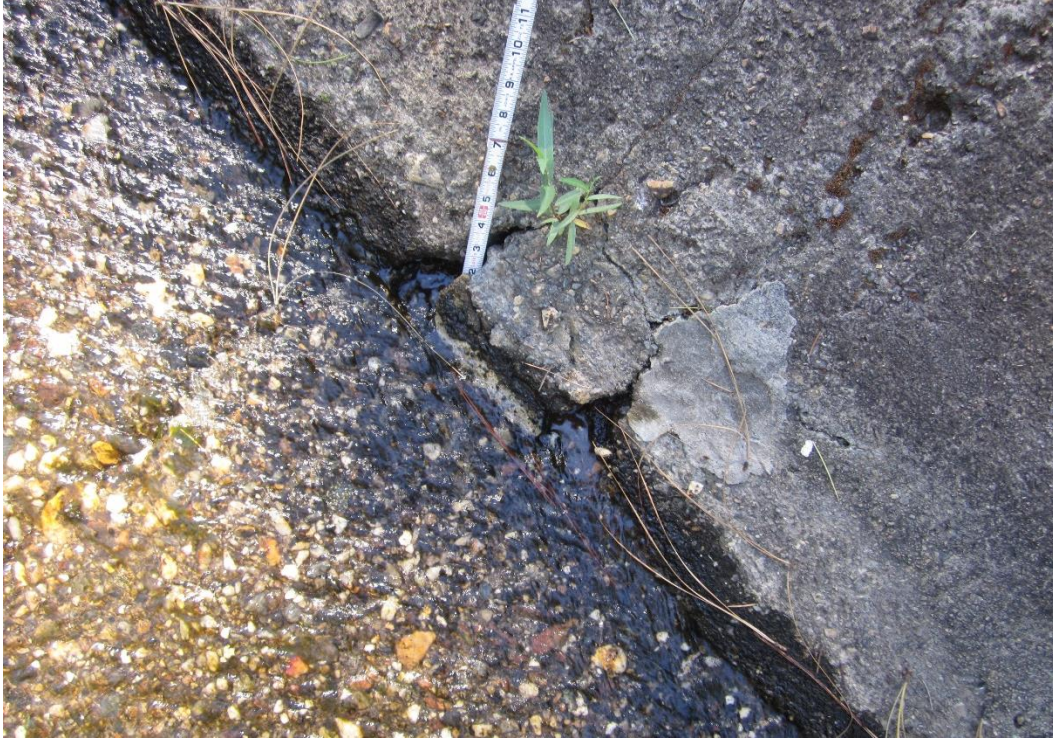
Figure 3-37: Holes in bottom of left side slab at left side of crack 9C.

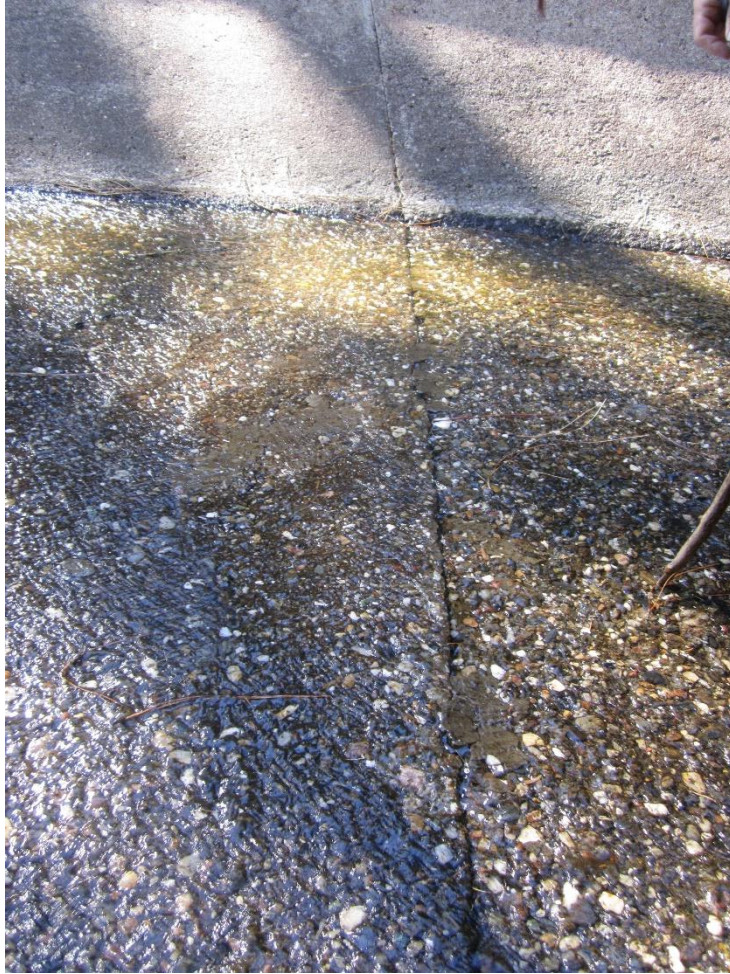
Figure 3-39: Transverse joint at Station 4+50.

The transverse joint at Station 4+50 had an approximate positive offset of 1/4" and maximum opening of approximately 1/2" and had been previously repaired (**Figure 3-39**). Downstream of this joint, each blanket drain outlet pipe daylighting near the right and left edges of the bottom slab was in good condition. There were six transverse cracks observed between transverse joints at Stations 4+50 and 4+75. The concrete comprising the bottom slab in this reach exhibited several cracks and areas of surficial deterioration (**Figure 3-40**). It is our opinion that the bottom slab should be reconstructed in this reach. The first crack (10A) was located at approximately 4.5' and was tight and had an area of deteriorated concrete on the right side (**Figure 3-41**). The second crack (10B) was located at approximately 6.5' and was tight (**Figure 3-42**). The third crack (10C) was located at approximately 8.5' and had been previously patched and had an area of deteriorated concrete upstream and to the right of the patch (**Figure 3-43**). The fourth crack (10D) was located at approximately 12' and had an area of deteriorated concrete in the center and left side (**Figure 3-44**). The fifth crack (10E) was located at approximately 18' and was tight. The sixth crack (10F) was located at approximately 19.5', had a maximum opening of approximately 1/8", had been previously patched, and had areas of deteriorated concrete along its length (**Figure 3-45**).

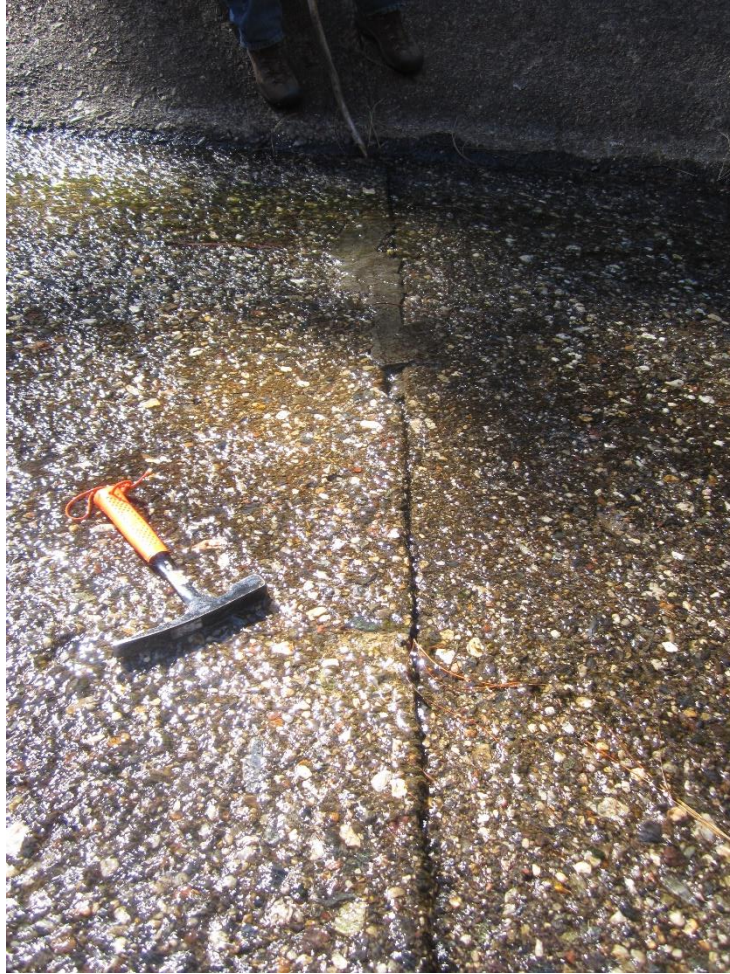
Figure 3-46: Transverse joint at Station 4+75.

The transverse joint at Station 4+75 had an approximate positive offset of 1/2" and maximum opening of approximately 1/2" and had been previously repaired (**Figure 3-46**). Downstream of this joint, each blanket drain outlet pipe daylighting near the right and left edges of the bottom slab was in good condition. There were five transverse cracks observed between transverse joints at Stations 4+75 and 5+00. The concrete comprising the bottom slab in this reach exhibited several cracks and areas of surficial deterioration (**Figure 3-47**). It is our opinion that the bottom slab should be reconstructed in this reach. The first crack (11A) was located at approximately 5.25' and was tight and had an area of deteriorated concrete (**Figure 3-48**). The second crack (11B) was located at approximately 9.75' and was tight (**Figure 3-49**). The third crack (11C) was located at approximately 14', had a maximum opening of approximately 1/2", had been previously patched, and had areas of deteriorated concrete along its center third which had a maximum depth of approximately 1.5" (**Figure 3-50**). The fourth crack (11D) was located at approximately 17' and was tight (**Figure 3-51**). The fifth crack (11E) was located at approximately 24.75', had a maximum opening of approximately 1/8", and had areas of deteriorated concrete which had a maximum depth of approximately 1" (**Figure 3-52**).

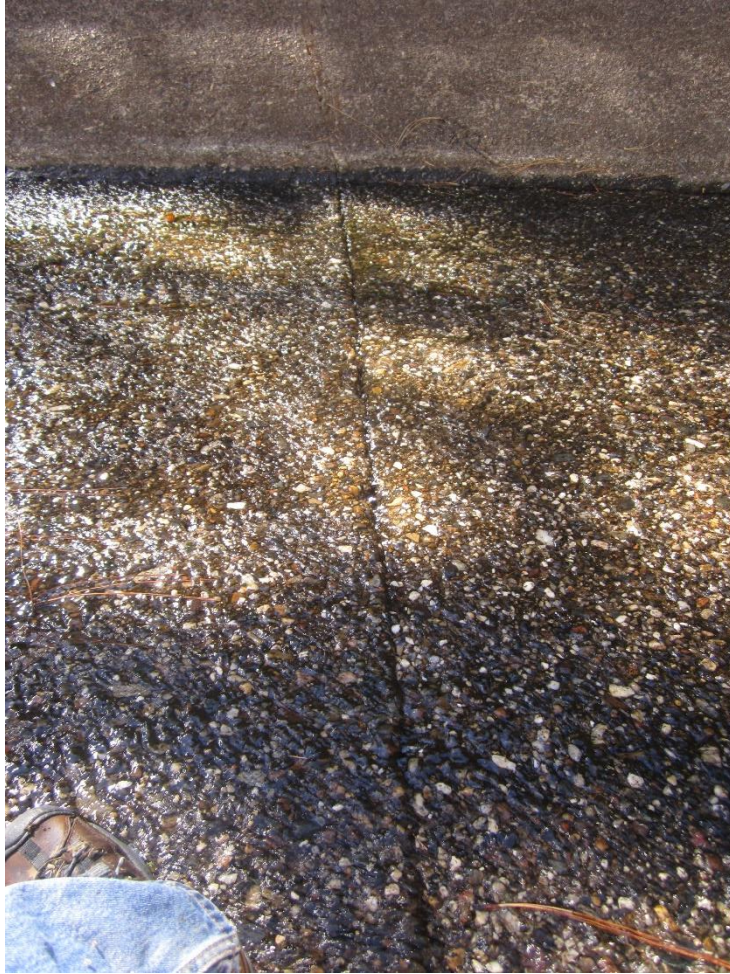
Figure 3-53: Transverse joint at Station 5+00.

The transverse joint at Station 5+00 had an approximate positive offset of 1/4" and maximum opening of approximately 1/2" (**Figure 3-53**). Downstream of this joint, each blanket drain outlet pipe daylighting near the right and left edges of the bottom slab was in good condition. There were four transverse cracks observed between transverse joints at Stations 5+00 and 5+25. The concrete comprising the bottom slab in this reach exhibited several cracks and areas of surficial deterioration. It is our opinion that the bottom slab should be reconstructed in this reach. The first crack (12A) was located at approximately 4.5' and was tight and had an area of significantly deteriorated concrete (**Figure 3-54**). The second crack (12B) was located at approximately 10.75' and had a maximum opening of approximately 1/4" (**Figure 3-55**). The third crack (12C) was located at approximately 13', had a maximum opening of approximately 1/8", (**Figure 3-56**). There was an area of deteriorated concrete located at approximately 18.5' (**Figure 3-57**). The fourth crack (12D) was located at approximately 21.25', had a maximum opening of approximately 1/4", and had areas of deteriorated concrete which had a maximum depth of approximately 2" (**Figure 3-58**). There were areas of deteriorated concrete located on the right and left sides at approximately 25' (**Figure 3-59**).

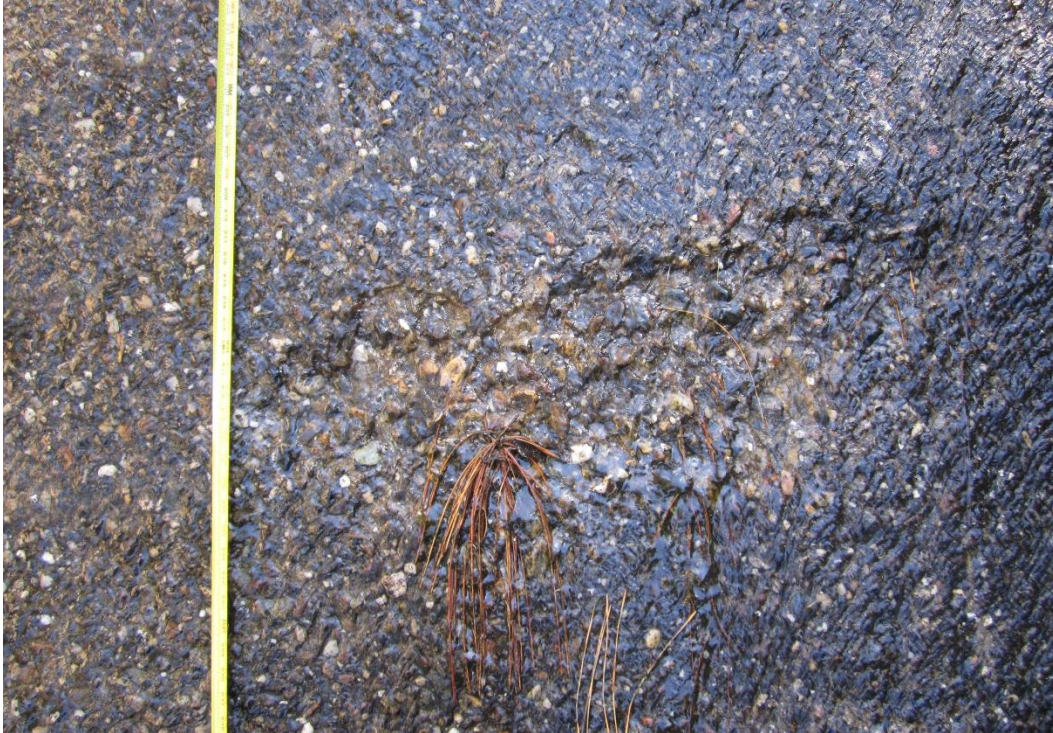
Figure 3-57: Area of deteriorated concrete at 18.5' downstream of Station 5+00.

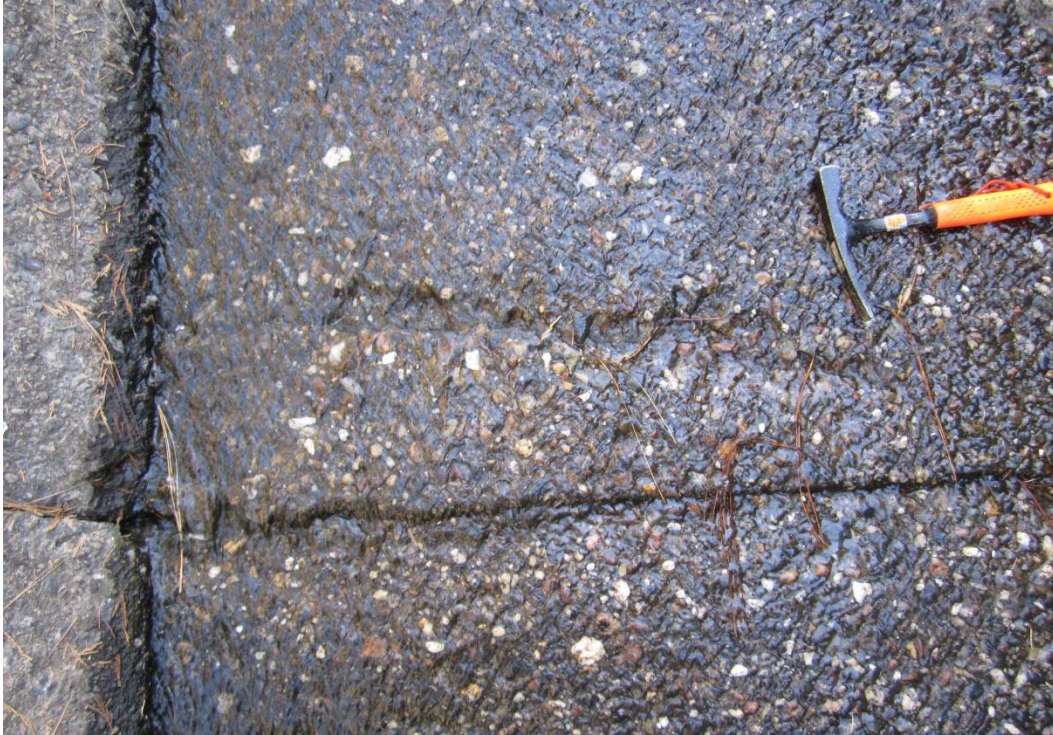
Figure 3-59: Area of deteriorated concrete at 25' downstream of Station 5+00.

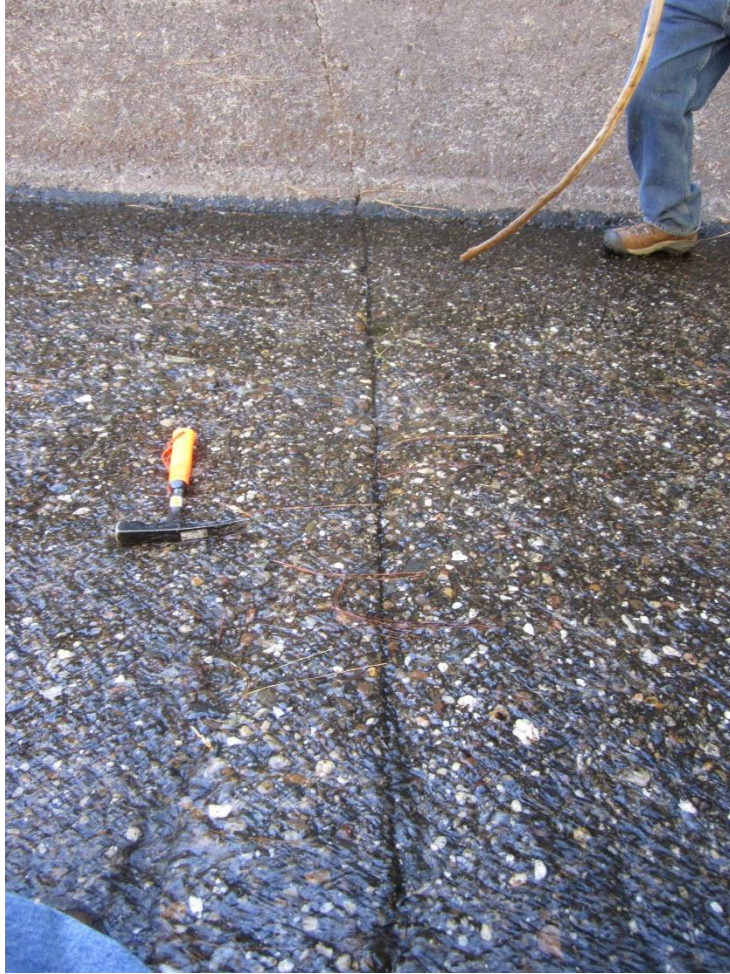
Figure 3-60: Transverse joint at Station 5+25.

The transverse joint at Station 5+25 had an approximate positive offset of 1/4" and maximum opening of approximately 1/8" (**Figure 3-60**). Downstream of this joint, each blanket drain outlet pipe daylighting near the right and left edges of the bottom slab was in good condition. There were five transverse cracks observed between transverse joints at Stations 5+25 and 5+50. The concrete comprising the bottom slab in this reach exhibited several cracks and areas of surficial deterioration (**Figure 3-61**). It is our opinion that the bottom slab should be reconstructed in this reach. The first crack (13A) was located at approximately 6.5' and had areas of deteriorated concrete along its length (**Figure 3-62**). The second crack (13B) was located at approximately 7.75' and had areas of deteriorated concrete along its length (**Figure 3-62**). The third crack (13C) was located at approximately 13.75', had a maximum opening of approximately 1/8", and had areas of deteriorated concrete along its length which had a maximum depth of approximately 1.5" (**Figure 3-63**). The fourth crack (13D) was located at approximately 15.75' and was tight and had areas of deteriorated concrete along its length which had a maximum depth of approximately 1" (**Figure 3-64**). There was an area of deteriorated concrete located at approximately 20-22' on the left side of the slab (**Figure 3-65**). The fifth crack (13E) was located at approximately 24.5', was tight, had been previously repaired, and had areas of deteriorated concrete which had a maximum depth of approximately 1.5" (**Figure 3-66**).

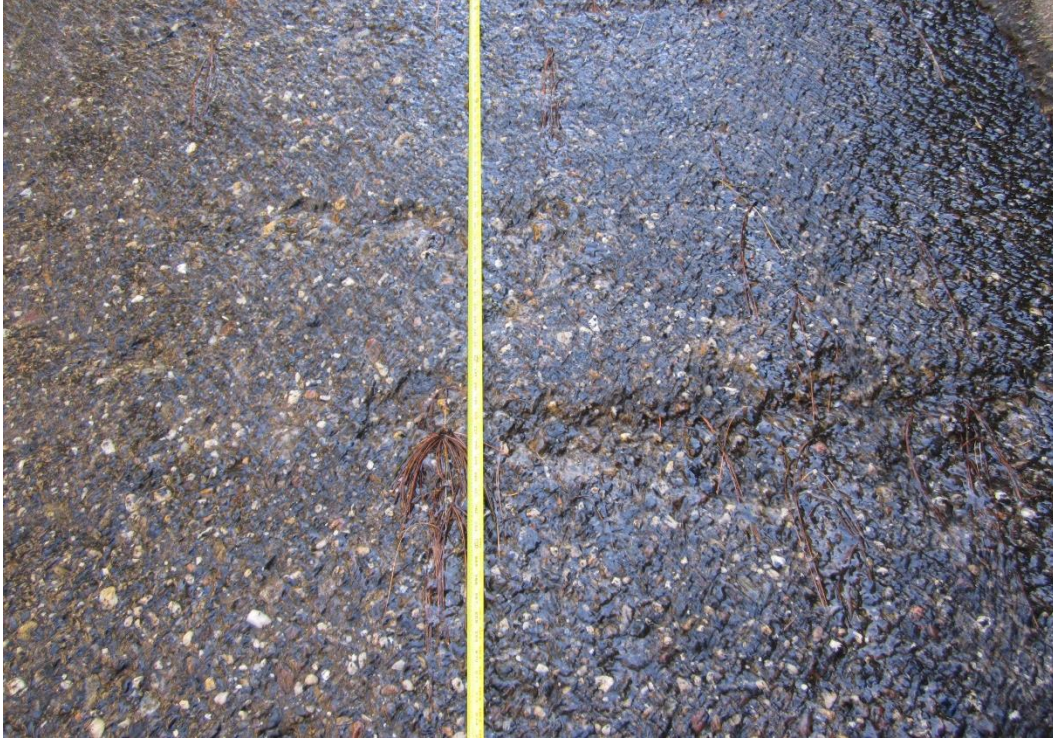
Figure 3-65: Area of deteriorated concrete at 20-22' downstream of Station 5+25.

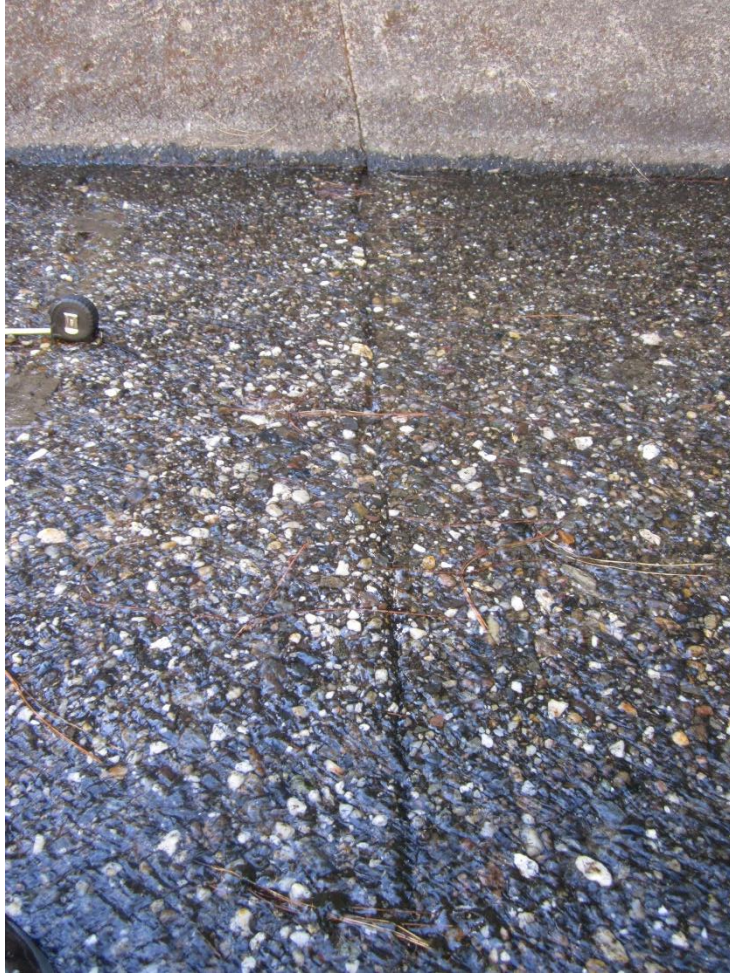
Figure 3-67: Transverse joint at Station 5+50.

The transverse joint at Station 5+50 had a maximum opening of approximately 1/8" (**Figure 3-67**). Downstream of this joint, each blanket drain outlet pipe daylighting near the right and left edges of the bottom slab was in good condition. There were three transverse cracks observed between transverse joints at Stations 5+50 and 5+75. The concrete comprising the bottom slab in this reach exhibited several cracks and areas of surficial deterioration (**Figure 3-68**). It is our opinion that the bottom slab should be reconstructed in this reach. The first crack (14A) was located at approximately 13' and had been previously repaired in the center (**Figure 3-69**). There was a hole 5" deep in the bottom of the right side slab at its junction with the bottom slab (**Figure 3-70**). This hole should be patched with repair mortar. The second crack (14B) was located at approximately 21.5' and was tight and had areas of deteriorated concrete along its length (**Figure 3-71**). The third crack (14C) was located at approximately 24' and was tight and had areas of deteriorated concrete along its length (**Figure 3-72**).
