REQUEST FOR PROPOSALS (RFP)

2024
Probable Maximum Flood Study

CPUD retained Mead & Hunt, Inc. (Mead & Hunt) to perform a focused spillway assessment comprised of four components: data collection and desktop study; detailed field inspection; focused potential failure modes analysis (PFMA); and reporting.

Warren Hayden, PE and Drake Hughes, PE of Mead & Hunt performed a detailed inspection of the Middle Fork Dam spillway on September 10, 2018. The weather conditions at the time of inspection were sunny and warm and there was approximately 0.5 inch of water flowing over the spillway crest. The inspection proceeded from the crest of the spillway to the toe of the chute.

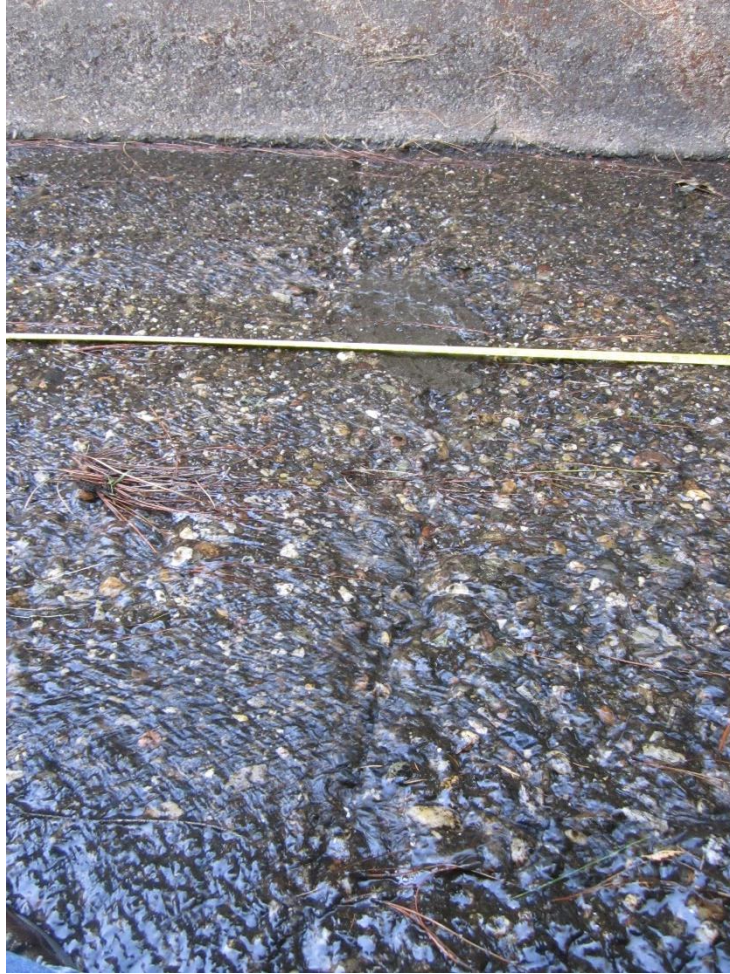
Figure 3-69: Crack 14A.

The transverse joint at Station 5+50 had a maximum opening of approximately 1/8" (**Figure 3-67**). Downstream of this joint, each blanket drain outlet pipe daylighting near the right and left edges of the bottom slab was in good condition. There were three transverse cracks observed between transverse joints at Stations 5+50 and 5+75. The concrete comprising the bottom slab in this reach exhibited several cracks and areas of surficial deterioration (**Figure 3-68**). It is our opinion that the bottom slab should be reconstructed in this reach. The first crack (14A) was located at approximately 13' and had been previously repaired in the center (**Figure 3-69**). There was a hole 5" deep in the bottom of the right side slab at its junction with the bottom slab (**Figure 3-70**). This hole should be patched with repair mortar. The second crack (14B) was located at approximately 21.5' and was tight and had areas of deteriorated concrete along its length (**Figure 3-71**). The third crack (14C) was located at approximately 24' and was tight and had areas of deteriorated concrete along its length (**Figure 3-72**).

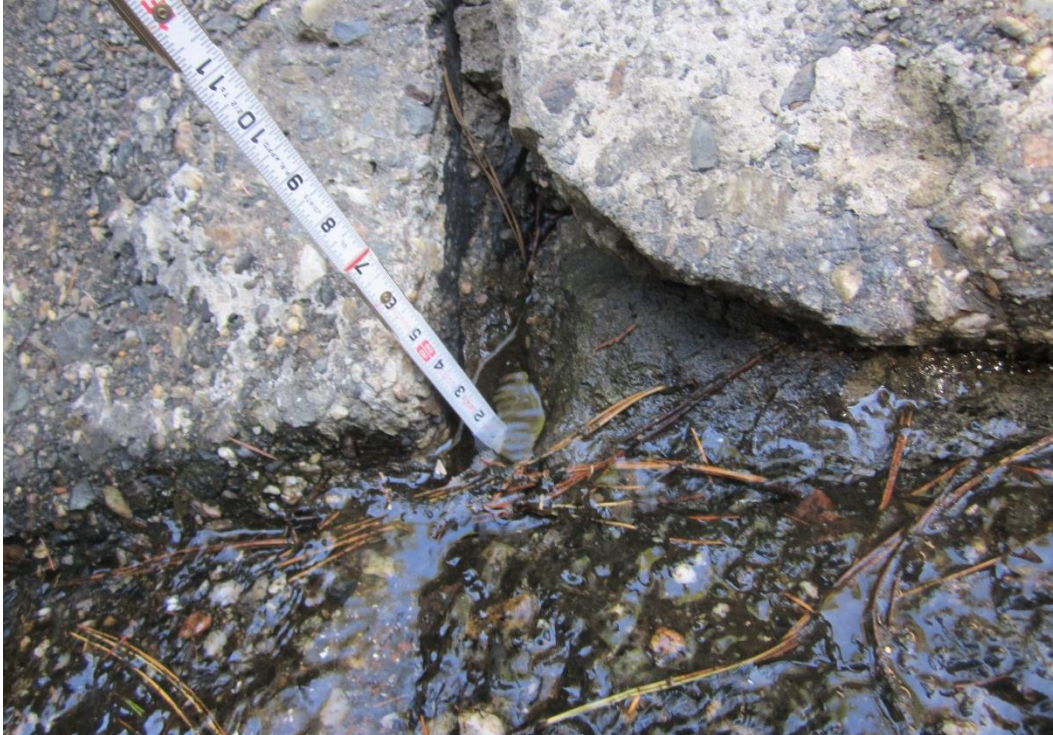
Figure 3-70: Hole at right side of crack 14A.

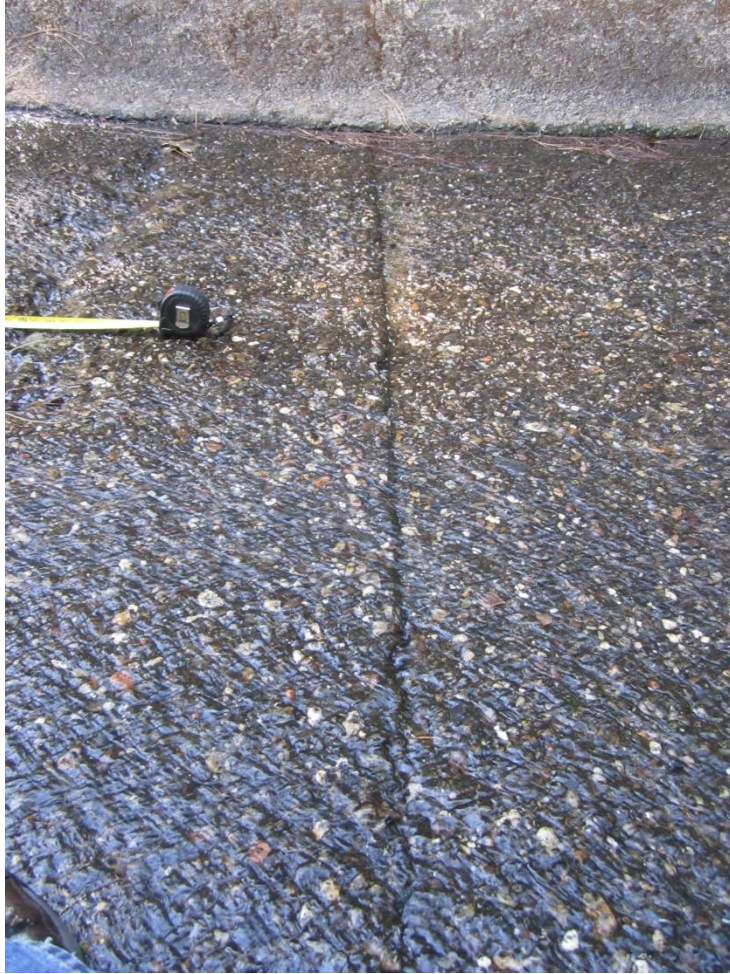
Figure 3-73: Transverse joint at Station 5+75.

The transverse joint at Station 5+75 had an approximate positive offset of 1/4" and maximum opening of approximately 1/4" (**Figure 3-73**). Downstream of this joint, each blanket drain outlet pipe daylighting near the right and left edges of the bottom slab was in good condition. There were four transverse cracks observed between transverse joints at Stations 5+75 and 6+00. The concrete comprising the bottom slab in this reach exhibited several cracks and areas of surficial deterioration (**Figure 3-74**). It is our opinion that the bottom slab should be reconstructed in this reach. The first crack (15A) was located at approximately 4.5' and was tight and had areas of deteriorated concrete along its length which had a maximum depth of approximately 1.5" (**Figure 3-75**). The second crack (15B) was located at approximately 8' and had areas of deteriorated concrete along its length (**Figure 3-76**). The third crack (15C) was located at approximately 13.5', was tight, had been previously repaired, and had areas of deteriorated concrete at the right side which had a maximum depth of approximately 1.5" (**Figure 3-77**). There was an area of deteriorated concrete located at approximately 22' which had a maximum depth of approximately 1.5" (**Figure 3-78**). The fourth crack (15D) was located at approximately 23.75' and was tight and had areas of deteriorated concrete along its length which had a maximum depth of approximately 1" (**Figure 3-79**).

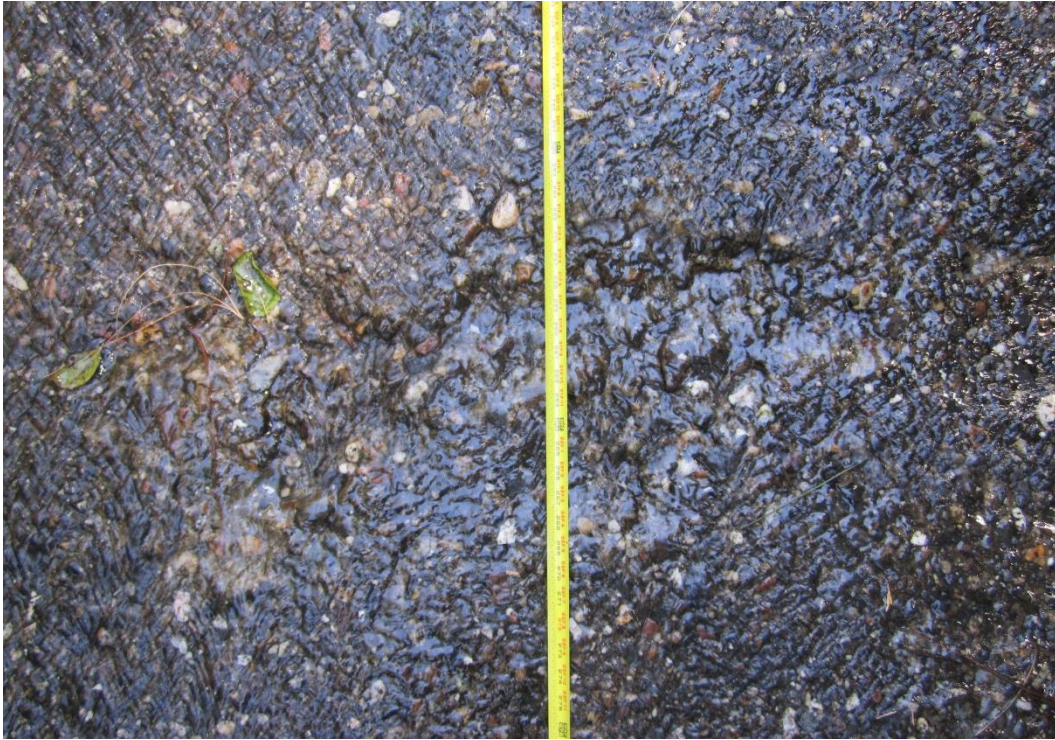
Figure 3-78: Area of deteriorated concrete at 22' downstream of Station 5+75.

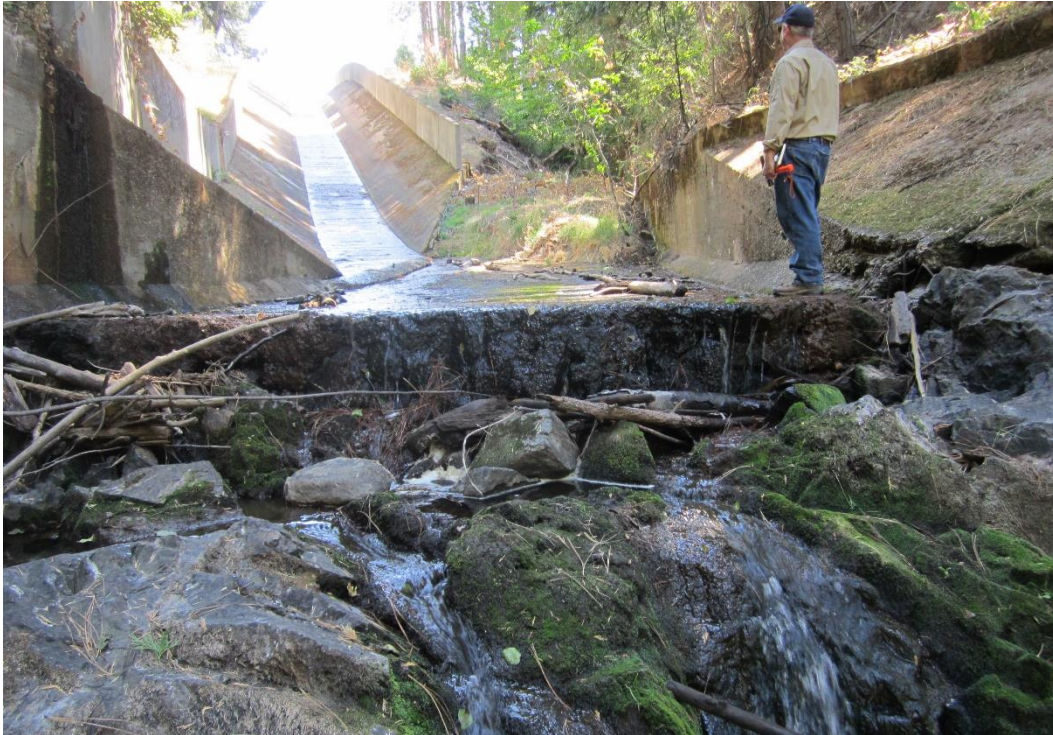
The transverse joint at Station 6+00 had an approximate positive offset of 1/2" and maximum opening of approximately 1/4" and deteriorated concrete along its right side (**Figure 3-80**). Downstream of this joint, four blanket drain outlet pipes in good condition daylight through the bottom slab. The concrete comprising the bottom slab downstream of Station 6+00 exhibited heavy surficial deterioration which had a maximum depth of approximately 2" (**Figure 3-81**). It is our opinion that the bottom slab should be reconstructed in this reach. The end of the chute bottom slab at approximately Station 6+70 showed no evidence of undermining (**Figure 3-82**).

Figure 3-82: End of chute bottom slab at approximately Station 6+70.
